Relationship between Environmental Conditions and Algal Growth on the Exterior Walls of the Ninna-ji Temple, Kyoto

6th International Building Physics Conference, IBPC 2015

Makiko Nakajima^a, Shuichi Hokoi^a, Daisuke Ogura^a, Chiemi IBA^{a,*}^aGraduate School of Engineering, Kyoto University, C-416, Kyotodaigakutsura, Nishikyo-ku, Kyoto-shi, 615-8246, Japan

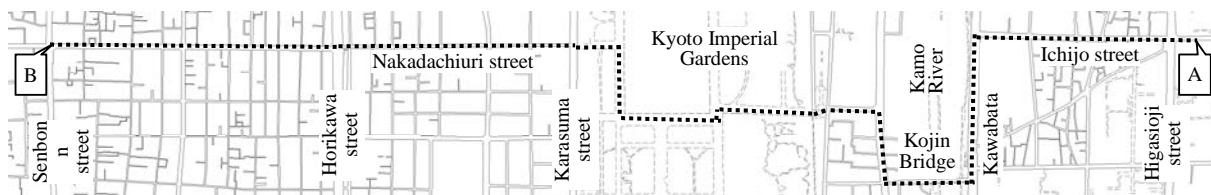
Fig. 1. Survey area.

The survey in Kyoto City was conducted to identify on which parts of the building walls the algae grow and which environmental factors affect algal growth. To study the effects of the local environment, a route passing through water areas (river and pond), green areas and urban areas was chosen. The surveyed area is along the east-west corridor of Ichijo street and Nakadachiuri street running from Kyoto University on the east to Senbon street on the west (Fig. 1). Surveys were conducted in October and November of 2008 and May of 2013. Photographs of exterior walls were taken with a digital camera in order to compare soiled and unsoiled areas. The surrounding environment, materials and the status of walls were documented. On the basis of a review and analysis of the photographs, the extent of soiling on the walls and causes of algal growth were estimated.
